Building Number: 7

Original Name: Water Control Building
(Water Plant)
(Water Treatment Plant)

Est. Year of Construction: 1951

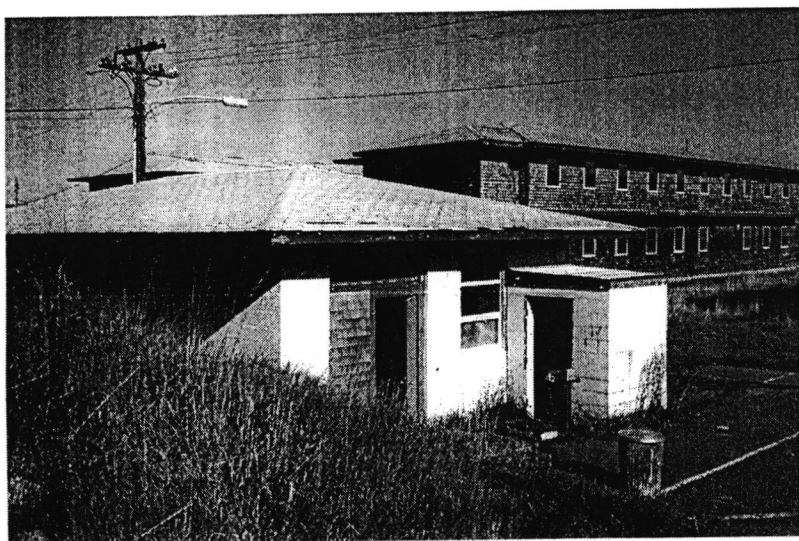
View from southwest.

- *Roof*
Low-pitched hipped roof with composition shingles in **fair/good condition**; maintain as is. Deep overhangs in **fair condition**. Recommend prepare and repaint all soffits.
- *Wall*
Exterior is constructed of painted concrete block (CMU) walls in **fair condition**. Paint is cracking/peeling. Recommend repoint and repaint 100%. Two entrances: double metal door is rusted and transom glass broken; replacement recommended. Wood frame with cedar shingle infill at side entrance. Single wood flush door in **fair condition**. Two aluminum 3-lite awning windows in **fair condition**.
- *Trim*
Existing wood door and window trim and wood fascia is in **fair/poor condition**. Recommend replacement of rotted sections (+/- 50 LF)- prepare and repaint all.
- *Foundation*
Poured concrete slab on grade in **good condition**.
